Castle Home Inspections, LLC

HOME INSPECTION REPORT

1234 Ideal St.
Bestown, NH 03333

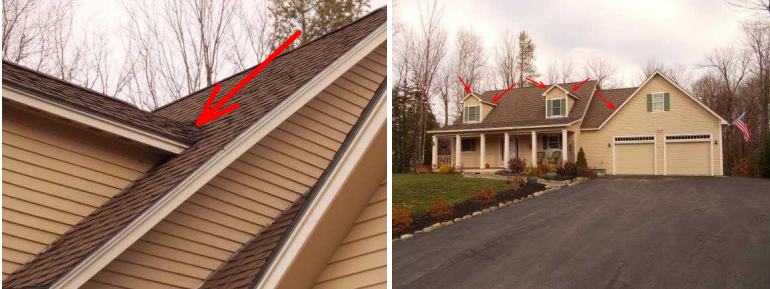
Marginal Material: Asphalt shingle - Signs of curling , cupping and significant wear in all valleys, will cause roofing to become brittle and shorten useful life of material

6. Main house Roof Surface Material: Asphalt shingle - Signs of curling , cupping and significant wear in all valleys, will cause roofing to become brittle and shorten useful life of material

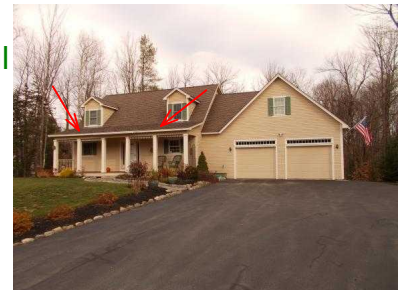
Marginal Material: Asphalt shingle - Signs of curling , cupping and significant wear, will cause roofing to become brittle and shorten useful life of material - budget for replacement 3 - 5 years

7. Porch Roof Surface Material: Asphalt shingle - Signs of curling , cupping and significant wear, will cause roofing to become brittle and shorten useful life of material - budget for replacement 3 - 5 years

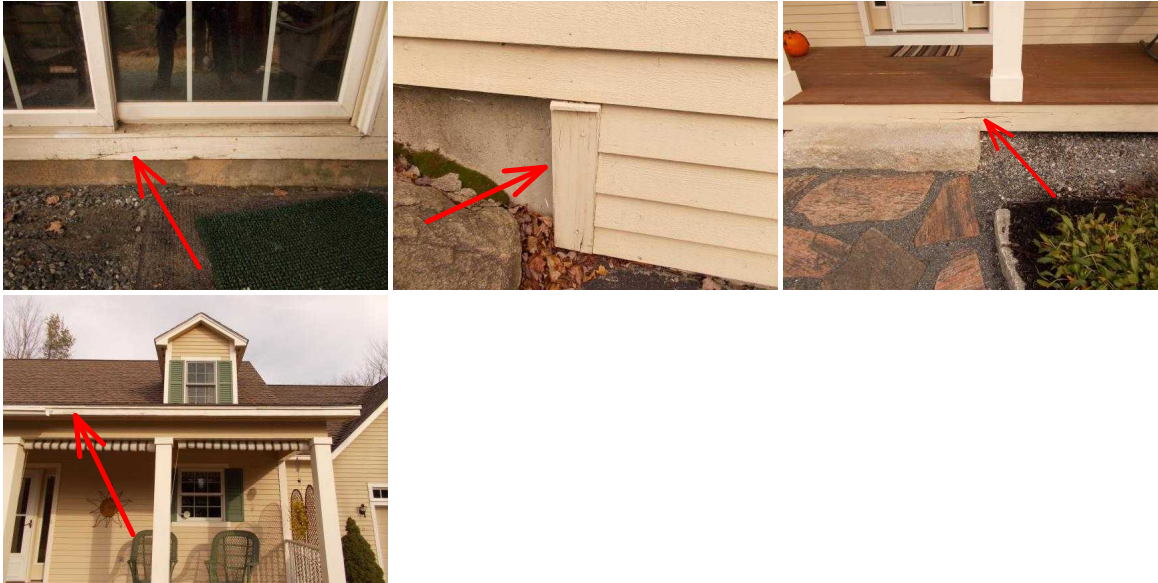
9. Trim: Wood - Wood rot noted

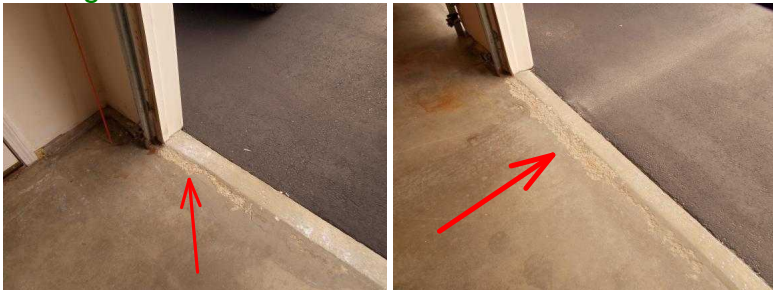
10. Attached Garage Floor/Foundation: Poured concrete - Spalled floor surface, Recommend water proofing floor surface

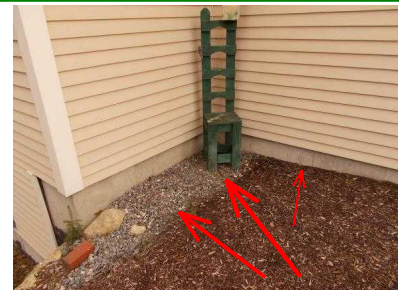
11. Grading: Negative slope - Left end

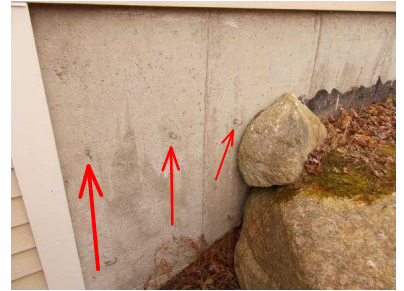
1. Full Basement Walls: Foundation walls exposed, Drywall - Break off foundation form tie ends - indoors and outdoors

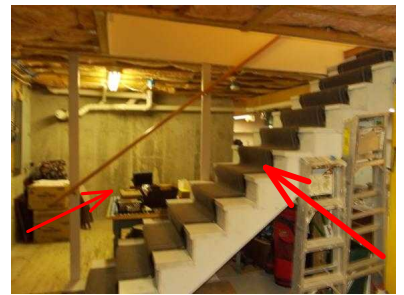
2. Full Basement Basement Stairs/Railings: Wood stairs with wood handrails - Open to one side, Handrail on one side only, No balusters on existing handrail

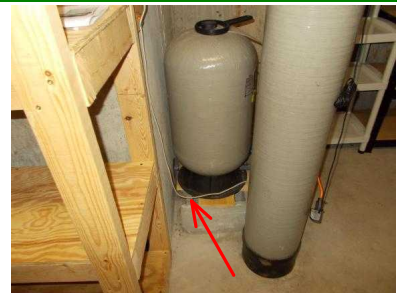
3. Pressure Tank: Metal tank - Electrical cable to pressure switch should be metal clad not romex

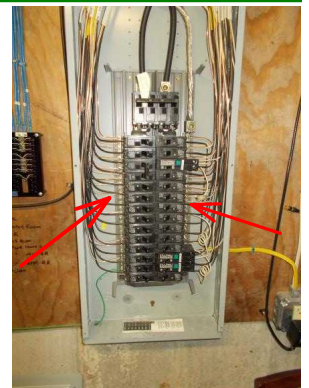
4. Basement Electric Panel Circuit connections: Neutral bar - Double tapping at neutral bar connections

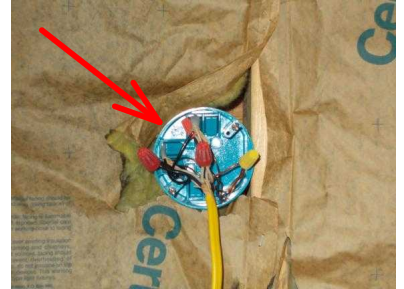
5. 1st Floor, 2nd Floor Living Space Electrical: 120 VAC - Install missing junction box cover plate - attic area over garage

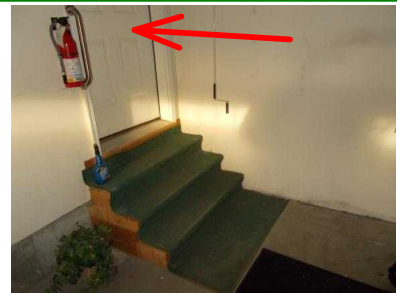
7. Attached Garage Service Doors: Interior Metal, Fire rated? Door not labeled as a fire door, Door does not have a closer mechanism

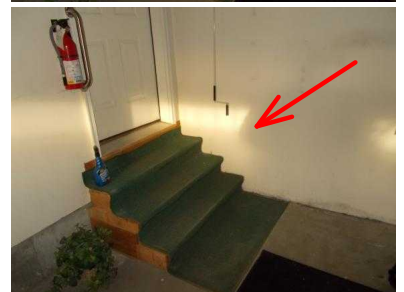
8. Attached Garage Stairs: Wood steps - No handrails

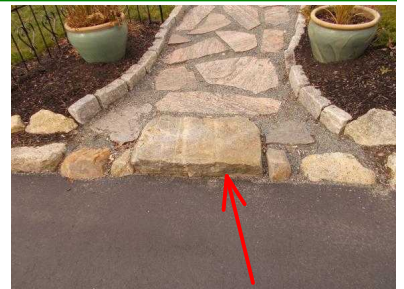
9. Walks: Flagstone - Walkway step - short riser, potential trip hazard

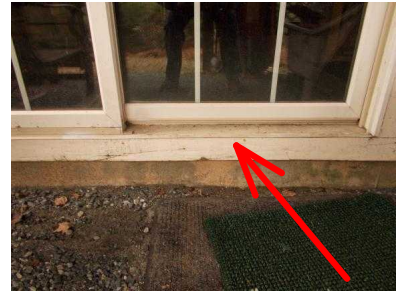
10. Exterior steps: Stone or granite - front OK. Step up at basement door - Risers too high, should be maximum 7 3/4" high

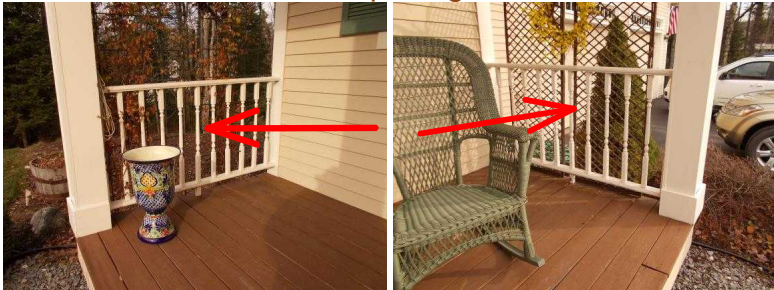
11. Porch: Wood - Baluster spacing too wide - should be less than 4"

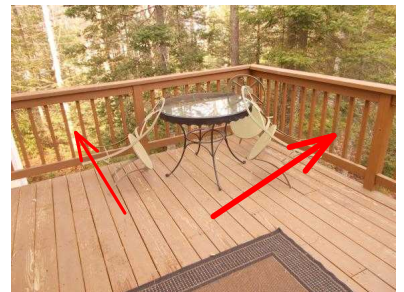
12. Deck: Treated wood - Baluster spacing too wide - should be less than 4"

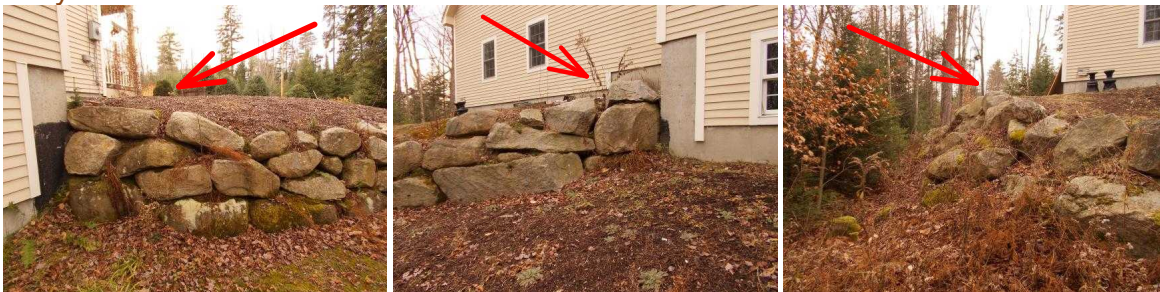
13. Retaining Walls: Stone - Wall (s) 30" or more above ground surface in some areas, no guardrails for safety

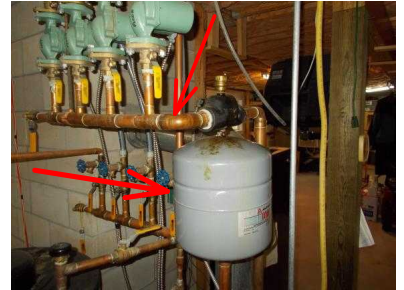
1. Basement Heating System Devices: Temperature/pressure gauge, Expansion tank, Backflow preventer, Pressure relief valve - **Expansion tank is water logged - replace tank. Distribution pipe near expansion tank needs a support bracket**
